URBAN WATER MANAGEMENT IN KINGSTON, NY:
PLACING GREEN INFRASTRUCTURE IN TEMPORAL & SPATIAL CONTEXT

A Thesis

of Cornell University

December 2018

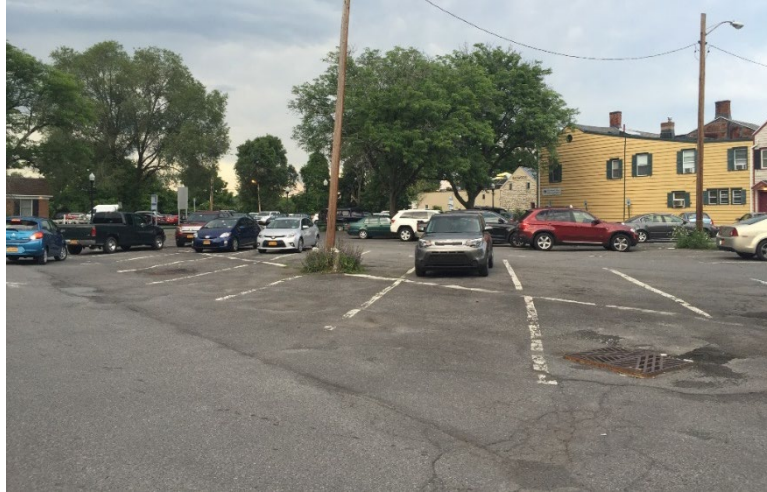
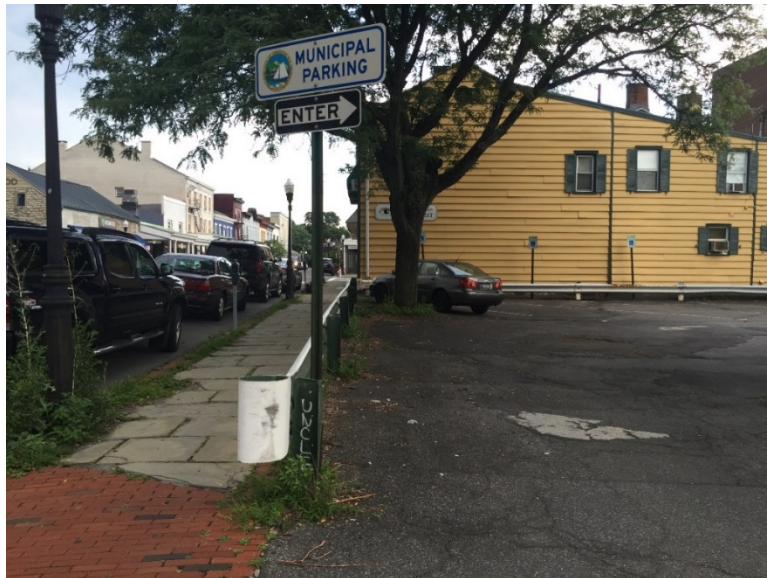
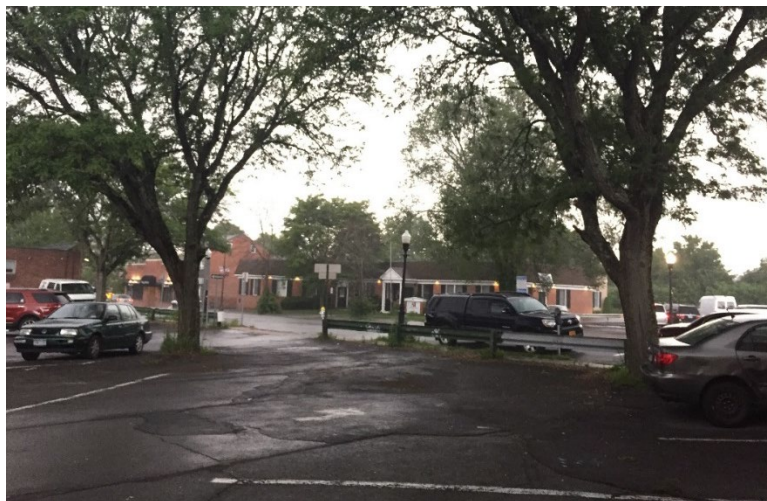
Prior to construction, both the South and North parking lots were in need of repair. They had substantially cracked asphalt that had been repaired in small pieces, creating a very uneven surface. The parking lots were also poorly lit, and parking stripes had faded.

The South parking lot had three stormwater catch basins connected to the storm sewer line on North Front Street, which discharged into a portion of the Tannery Brook that was piped and buried (Figure 1.2). This parking lot also had three large trees, which were removed during construction. The roots of these trees had buckled the asphalt considerably.

Figure 1.2: Pre-construction conditions in the South parking lot, including existing catch basins, trees, and guardrail (July 18, 2016).

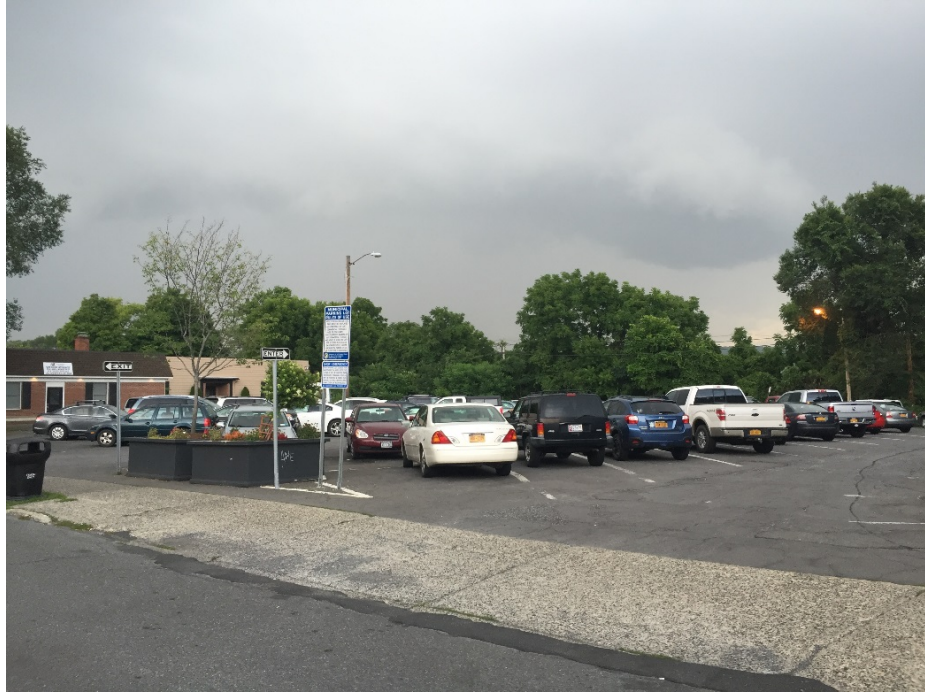
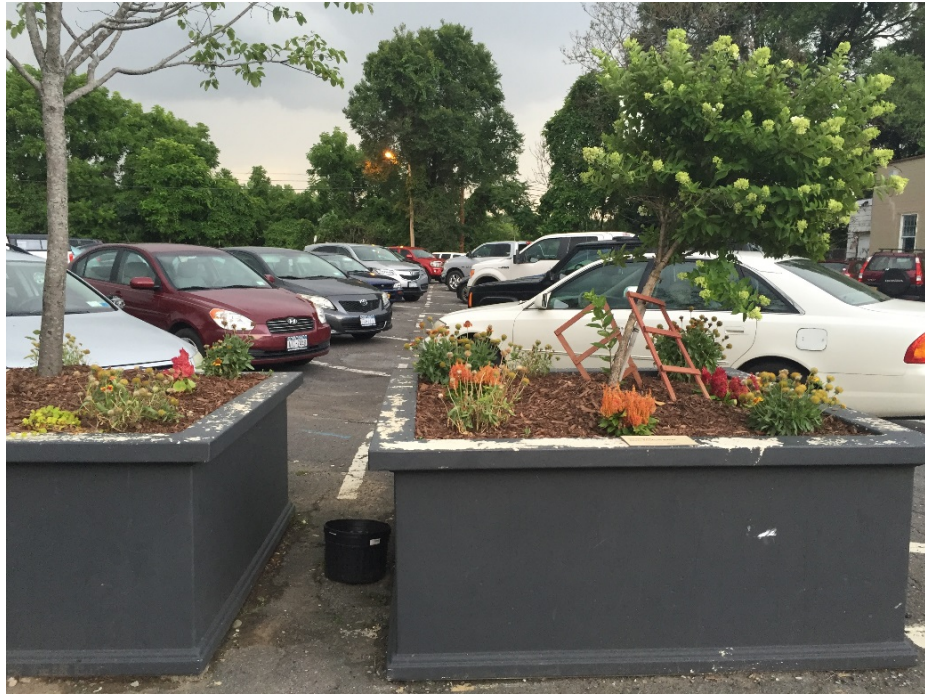
The North parking lot did not have catch basins. Runoff would form large puddles or sheetflow to the north of the parking lot and down a steep vegetated slope (Figure 1.3). Downslope are parking lots owned by Romeo KIA of Kingston and another, adjacent to Stockade Drive. The North parking lot also had two large vegetated planter boxes; these planters were located throughout the Uptown neighborhood (Figure 1.4).

Figure 1.4: Pre-construction conditions in the North parking lot, including planter boxes with vegetation (July 18, 2016).

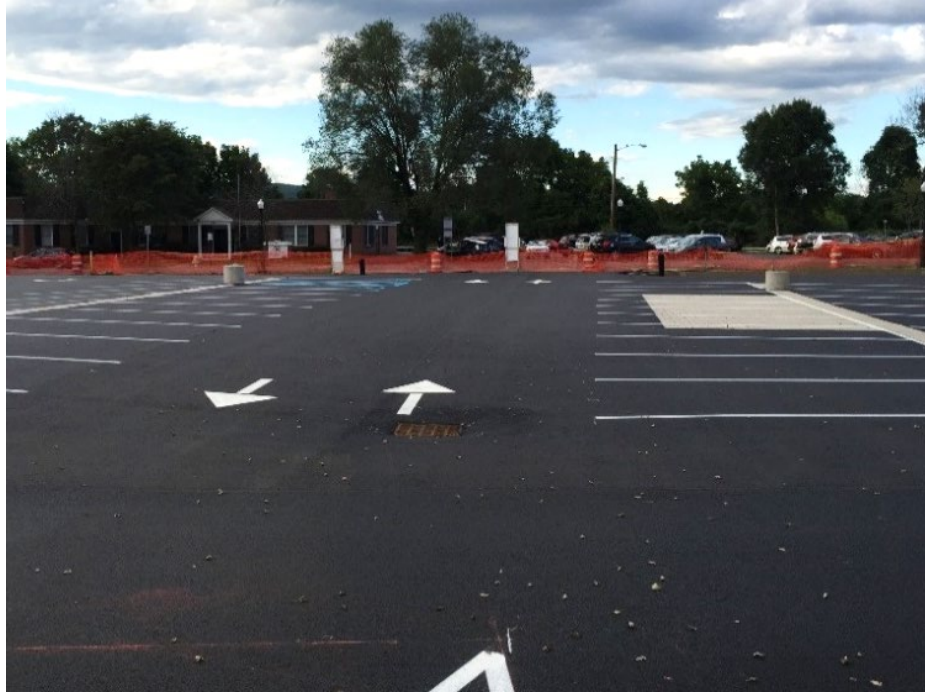
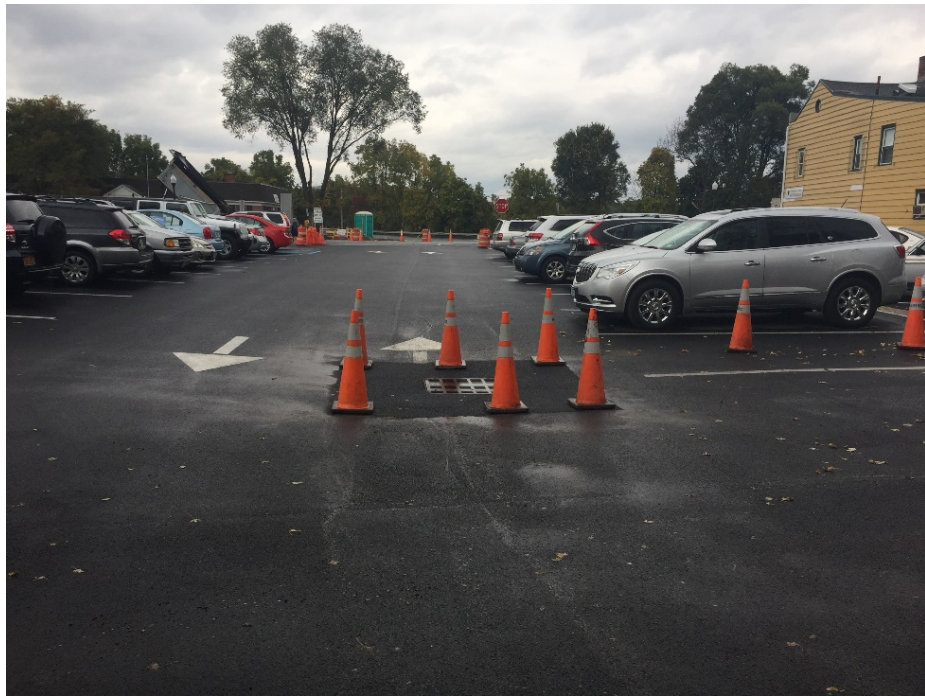
The grate of Dry Well South 2 was originally too far below the grade of the parking lot. Although this did not directly impact the drainage area for the green infrastructure practice, grading around the grate created a steep depression that was difficult for vehicles to clear. After the parking lot had been open about a month and a half, the City of Kingston raised the grate and asphalt around Dry Well South 2 about 3.5 inches, although the concrete cast portion of the dry well stayed in the same place (Figure 3.1). This was done around October 13, 2016. Raising it still allowed for stormwater to enter the dry well, but better protected vehicles.

Figure 3.1: Grading around Dry Well South 2. Originally grading was too steep (top, September 1, 2016), and the grate was raised about 3.5 inches (bottom, October 13, 2016).

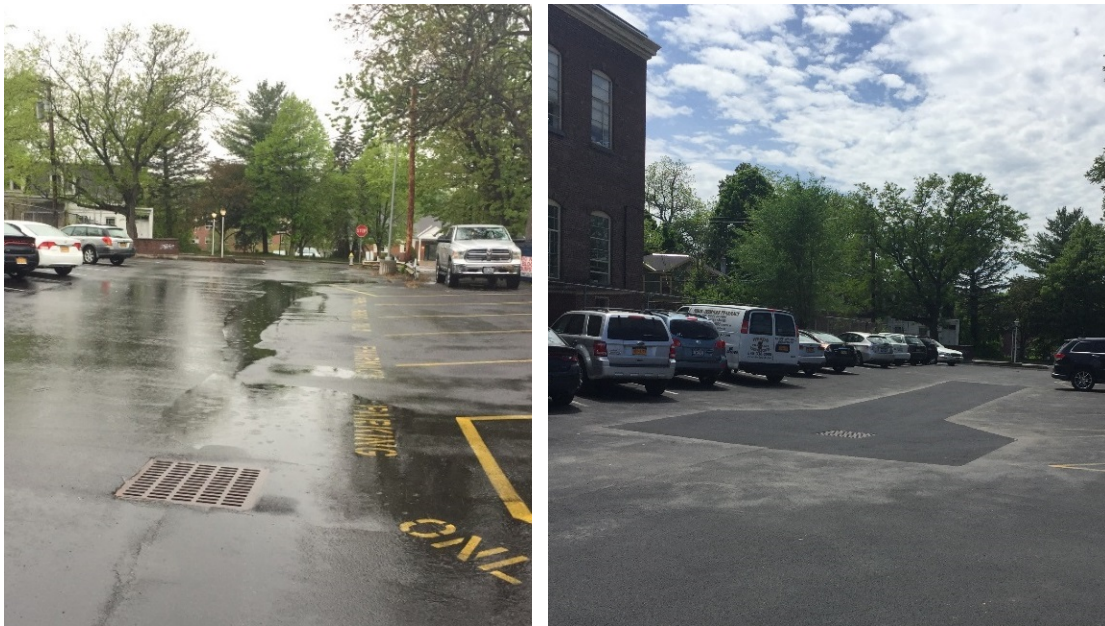
In contrast, the grate of Dry Well South 1 was not low enough to receive runoff from its designed drainage area. After construction, stormwater was bypassing the dry well and flowing into Green Street's storm sewers (Figure 3.2). Stormwater from the southwest corner of the South parking lot was designed to flow into the conventional stormwater system on Green Street, without treatment by green infrastructure practices. However, the grading error resulted in stormwater from the drainage area intended for Dry Well South 1 to also flow in this direction. By May 20, 2017, the City of Kingston regraded the asphalt surrounding that dry well, allowing for substantially more water to be treated by the practice.

Figure 3.2: Grading around Dry Well South 1. Before regrading, stormwater was bypassing the grate and flowing west into Green Street (left, May 5, 2017). New grading allowed this practice to capture runoff from a much larger area of the parking lot (right, May 20, 2017).

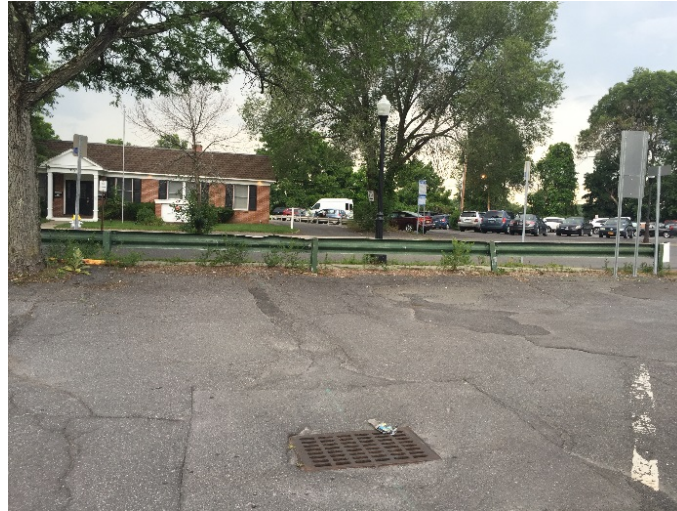
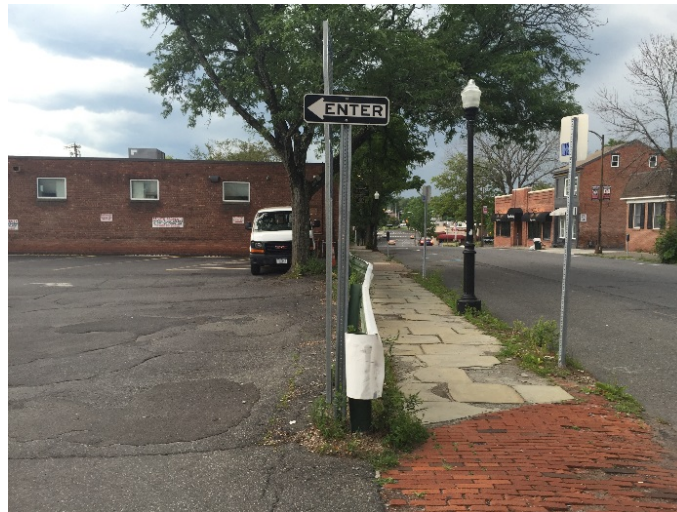
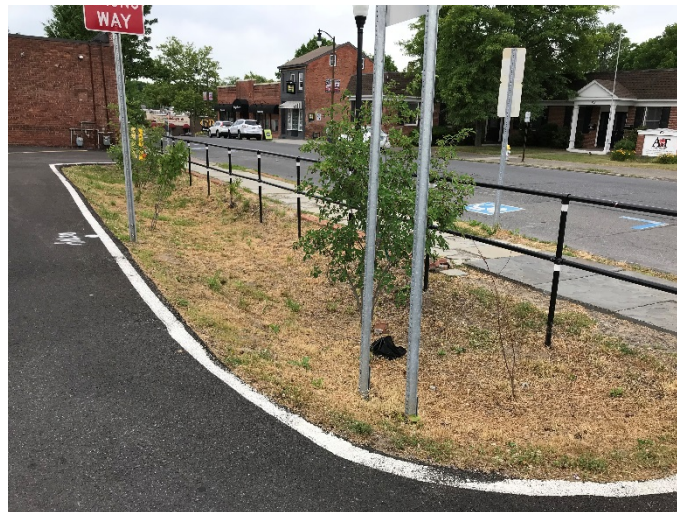
The new design of both parking lots changed the configuration of the entrances, parking spaces, and driving lanes within the lots. The North lot previously had two entrances, and one of those was replaced by Bioretention Area North. Several cars accidentally drove into and through this practice after construction (Figure 3.7). In addition to being a safety hazard, this could have compacted soil and compromised the bioretention area's performance. The entrance of the South lot remained the same, and cars did not appear to drive into the bioretention areas on this side. The South lot also originally had guardrails between the parking lot and the sidewalk, where the bioretention areas were located after construction (Figure 3.8).

Figure 3.8: Guardrail in the South parking lot before construction (top and middle, July 18, 2016), where Bioretention Area South 2 was installed (bottom, June 20, 2017).

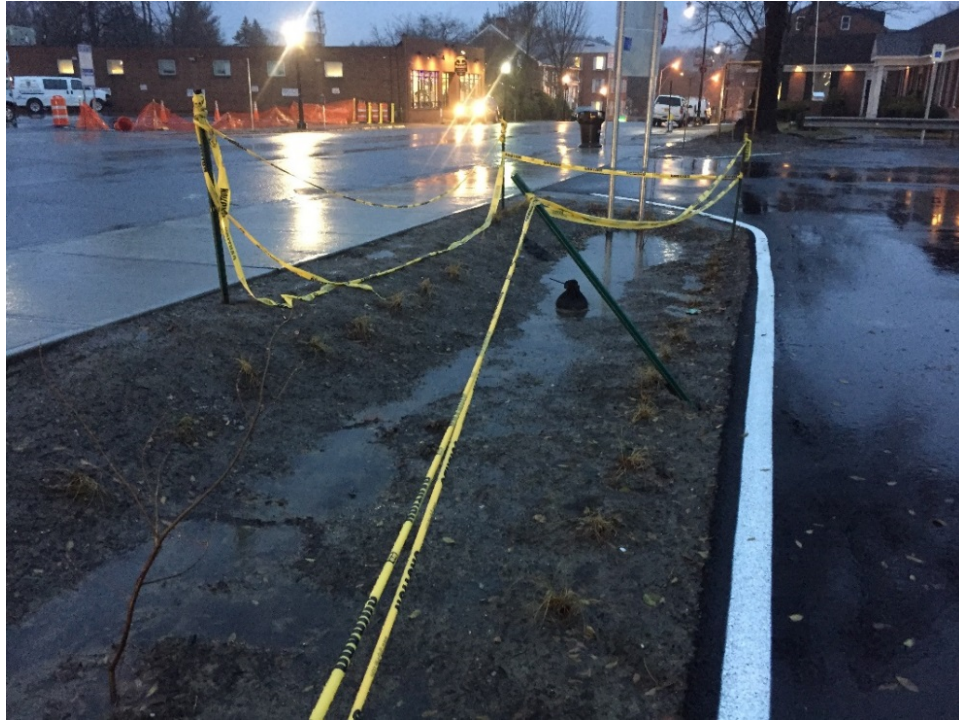
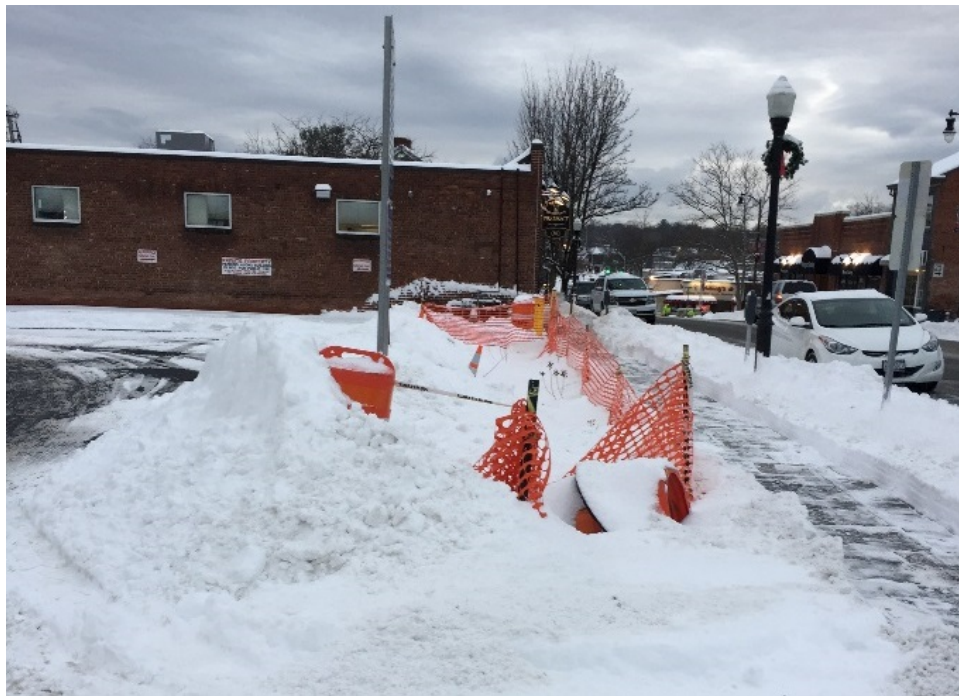
All of the rain gardens and bioretention areas were designed to receive sheetflow runoff from their entire perimeter, and as such, there was no curbing or physical barrier between the asphalt and the vegetation. Cones and construction fencing surrounded the bioretention areas in both parking lots for about three months after construction (Figure 3.9). By the end of December 2016 they were removed and replaced by metal fencing along the sidewalk side of the bioretention areas. These metal fences separated the bioretention areas from the sidewalk and roads to improve safety and prevent vehicles from crossing through the practices (Figure 3.10). The fences included reflective tape for better visibility at night. Installation of the fencing began in the South lot on December 28, 2016 and was completed for all three bioretention areas by January 6, 2017.

Figure 3.9: Caution tape up in Bioretention Area North (top, November 30, 2016) and construction fencing in Bioretention Area South 2 (bottom, December 17, 2016). The caution tape was removed in the first week of December 2016, and the construction fencing in all bioretention areas was removed by the end of the month.

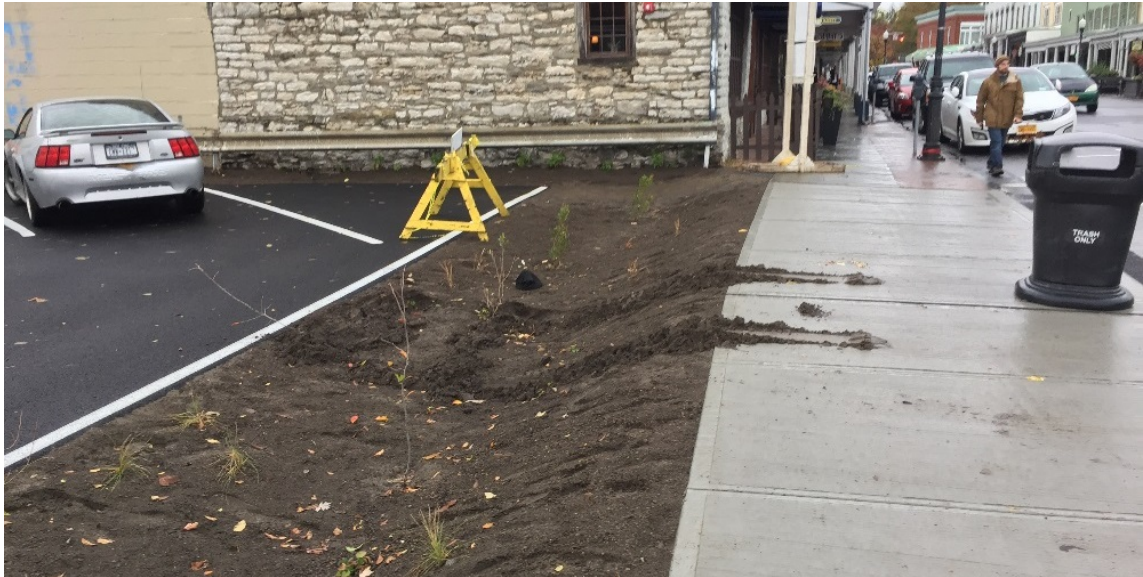
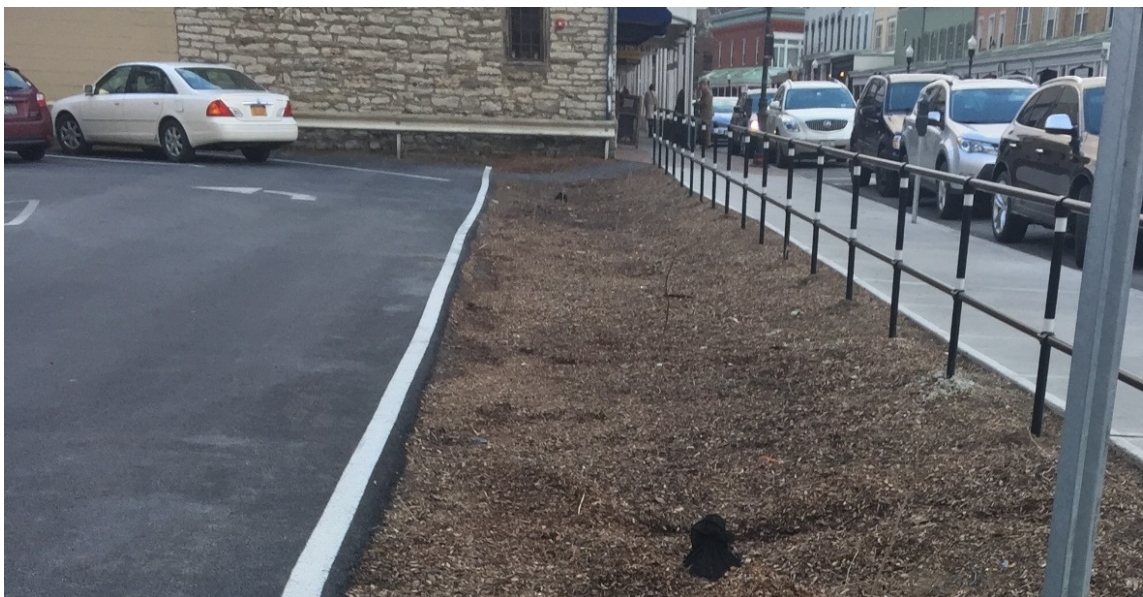
Figure 3.10: Bioretention Area North before (top, October 26, 2016) and after (bottom, February 26, 2017) metal fences were installed.

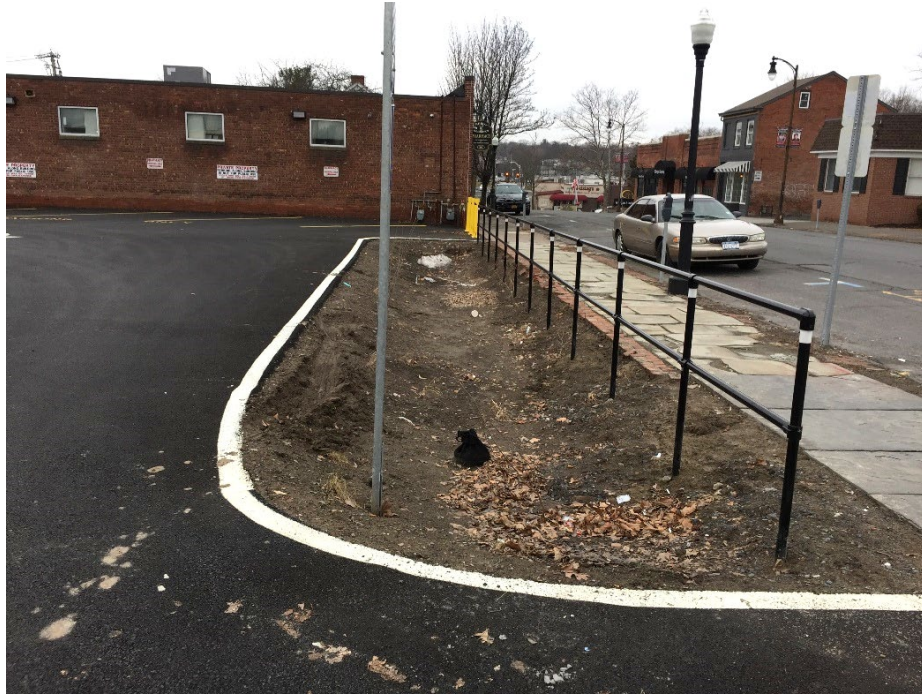
With the exception of the guardrail along Rain Garden North, none of the vegetated practices had physical barriers on the parking lot side. It appeared that cars drove through the edges of the bioretention areas in both the North and South lot when turning within the parking lots (Figure 3.11). The re-design of the driving lanes required cars to take tight turns.

Figure 3.11: Tire tracks through the edge of Bioretention Area South 2, after fences were installed (January 22, 2017).

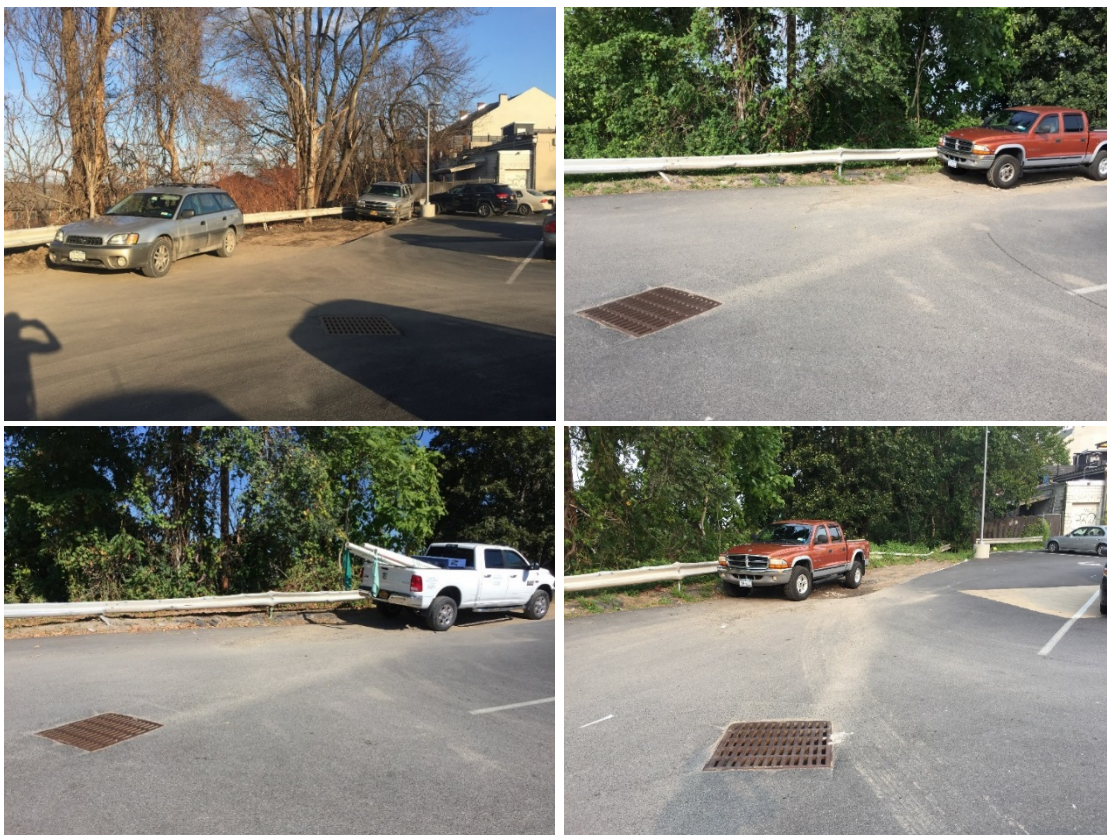
Although not designed to be green infrastructure, there were several areas of green space within the parking lots that were intended to be planted with grass, perennial bulbs, daylilies, or other vegetation less than 30 inches tall (Barton & Loguidice 2015a). These areas were never planted, and instead were left as bare soil. Some of these areas filled in with weeds.

In the North lot, one of these areas that was intended to be vegetated was frequently used for parking (Figure 3.12). The curve of that particular driving lane was also sharply angled, and it appeared that some vehicles took the turn through the bare soil (Figure 3.13). This compacted the soil, and also mobilized sediment that was carried across the parking lot toward Dry Well North 1 and Pervious Pavers North 1. Due to the compacted soil and frequent disturbance, vegetation did not establish here.

Figure 3.12: Vehicles parked in an area of bare soil in the North lot that was designed to be vegetated. (Clockwise from top left: February 24, 2017; August 17, 2017; September 5, 2017; and September 28, 2017.)

The bare soil area in the North parking lot was a high priority issue to resolve. Sediment from this area traveled directly into the North parking lot dry wells and pervious pavement, and the illegal parking there was not enforced. The City of Kingston eventually placed a large planter box on top of the bare soil to add vegetation and dissuade people from parking there. This planter contained vegetation, and was similar to what had previously been near the entrance of the North parking lot before construction (Figure 1.4). Although similar landscaping features were located throughout the neighborhood, this planter box looked out of place at the back of the parking lot, within an irregularly shaped patch of bare soil.

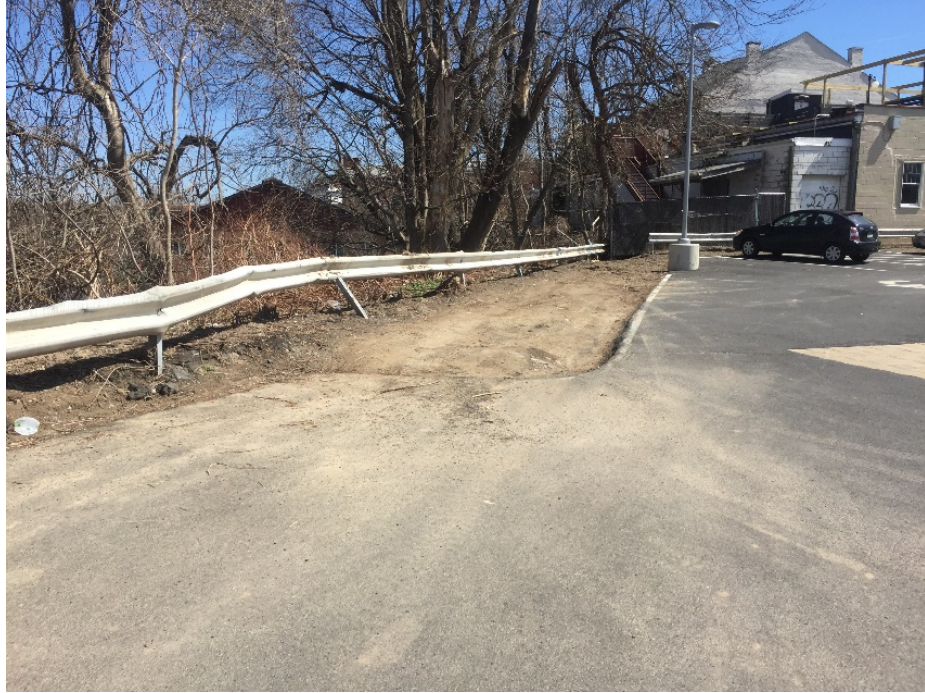
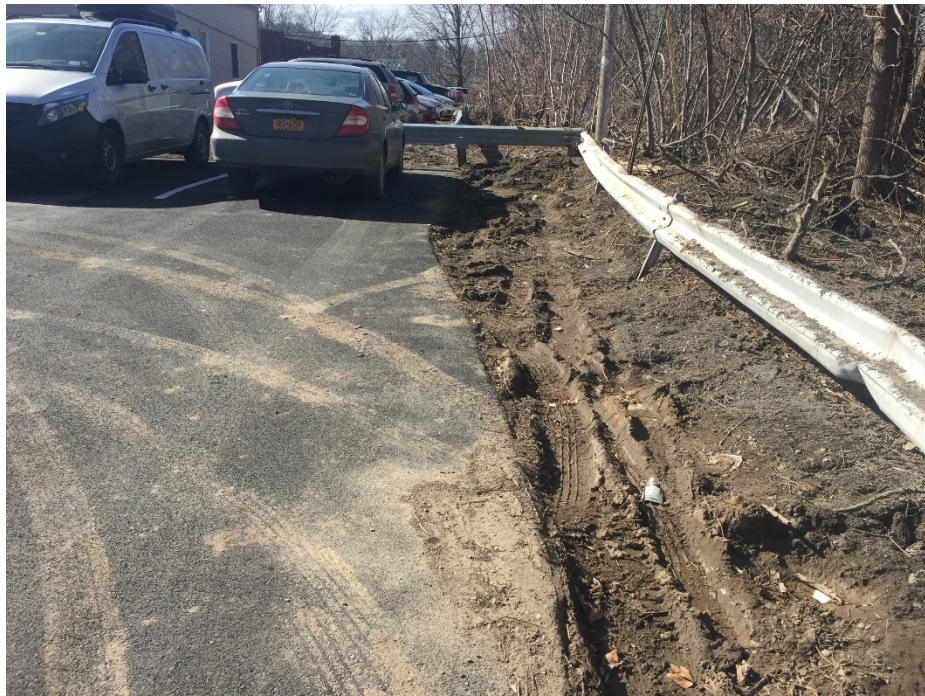
Figure 3.13: Tire tracks through areas of bare soil in the North lot that were designed to be vegetated. (Top, April 9, 2017; bottom, February 24, 2017.)

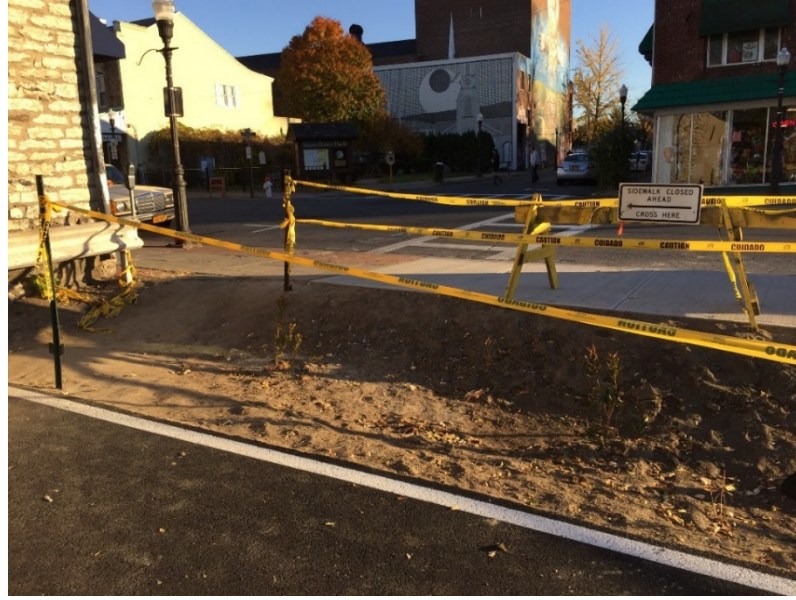
the businesses in the Uptown neighborhood. According to the plans, these area were designed to be part of the stormwater practices (Barton & Loguidice 2015a). As people crossed through them, it compacted the soil and reduced the storage of those bioretention areas. Signs posted during construction were confusing, and seemed to indicate that pedestrians should be crossing through the edges of the bioretention areas (Figure 3.15).

Figure 3.15: Sign in Bioretention North indicating that pedestrians should cross through the stormwater practice (November 7, 2016). The sign reads, “SIDEWALK CLOSED AHEAD CROSS HERE.” The sidewalk was also not closed at this time.

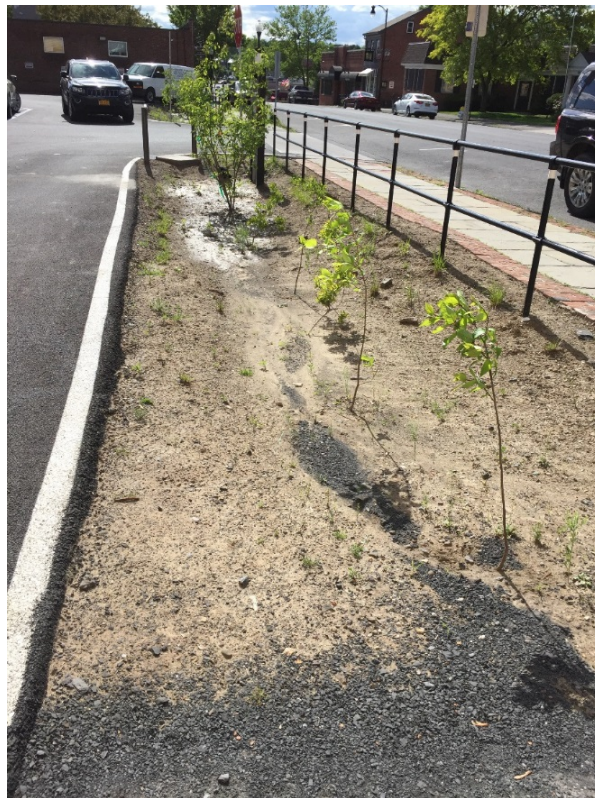
These pathways resulted in an informal walkway through Bioretention Area North and South 1, which were used even in wet weather when the practices were muddy. After fencing was installed around the bioretention areas at the end of December 2016/beginning of January 2017, there was clearly space left for pedestrians to walk through at this location. The City of Kingston added gravel to make these walkways more formal in January 2017. Eventually, the gravel was carried with runoff into the bioretention areas. This issue was exacerbated in Bioretention South 1 by a downspout from an adjacent building that directed runoff across the gravel walkway and into the bioretention area (Figure 3.16).

Figure 3.16: Erosion of gravel walkway into Bioretention Area South 1 (June 2, 2017).

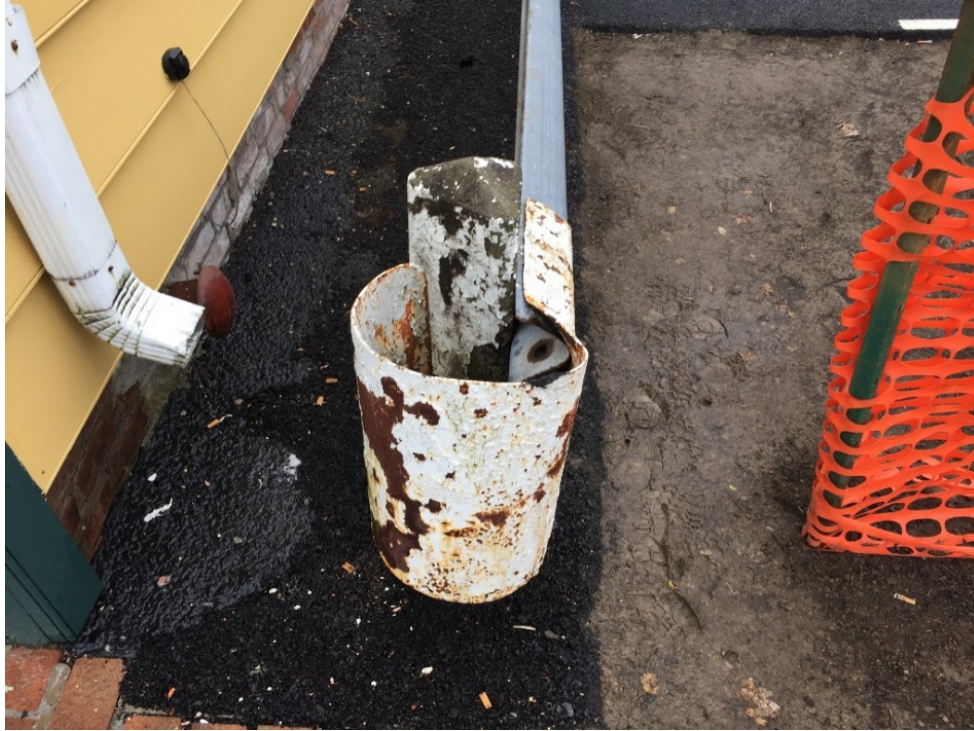
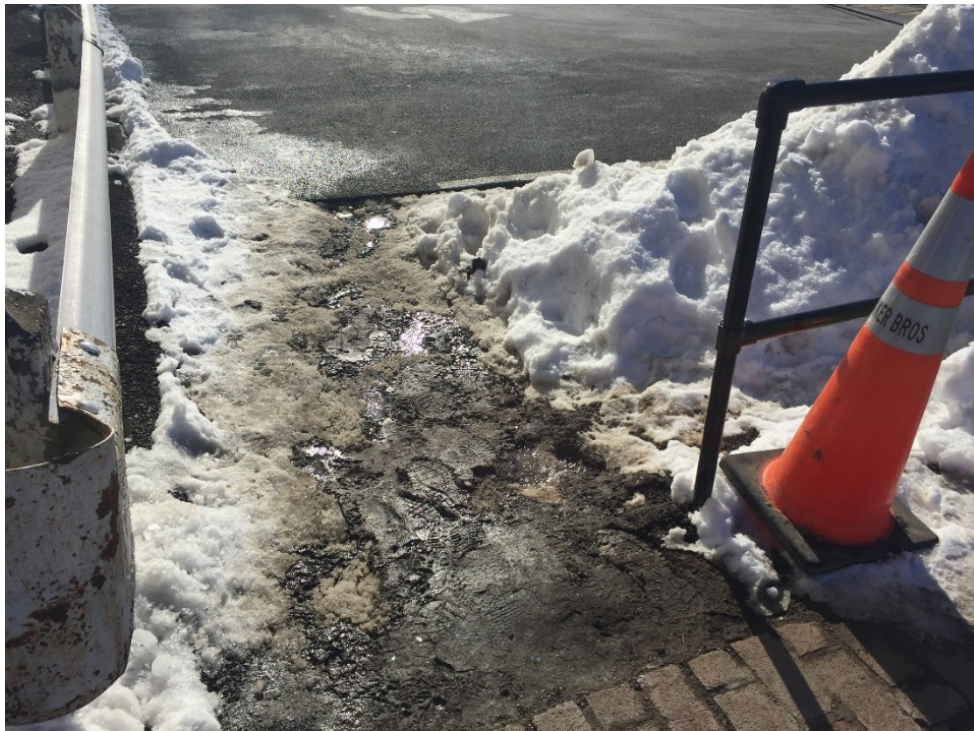
Figure 3.17: Informal walkway through Bioretention Area South 1 on October 22, 2016 with construction fencing (top) and January 1, 2017 with metal fences (bottom).

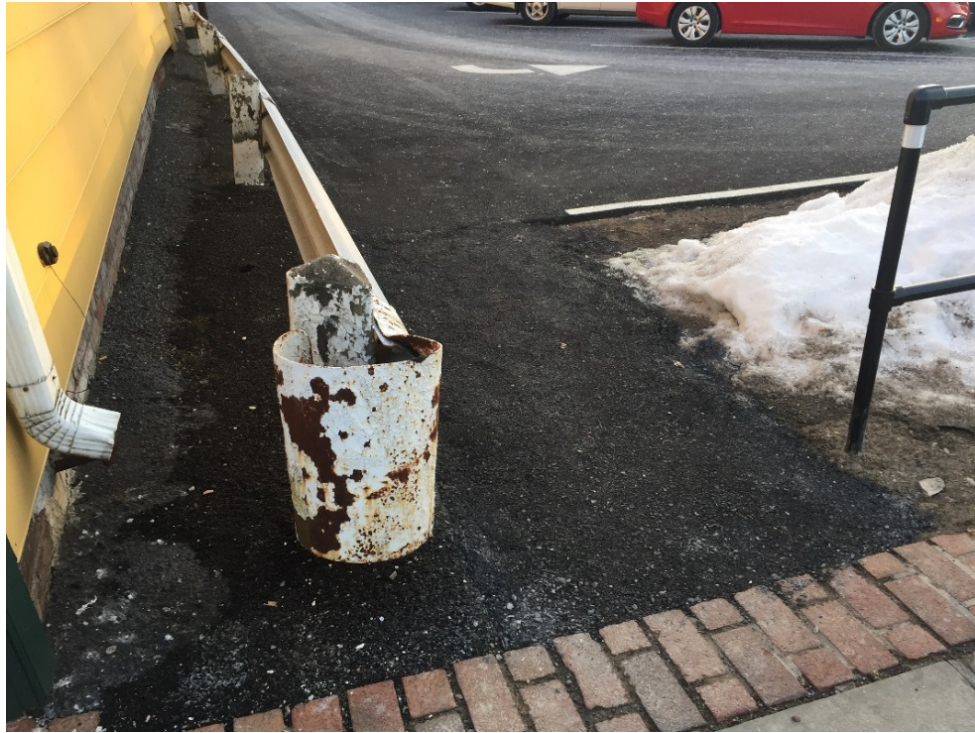
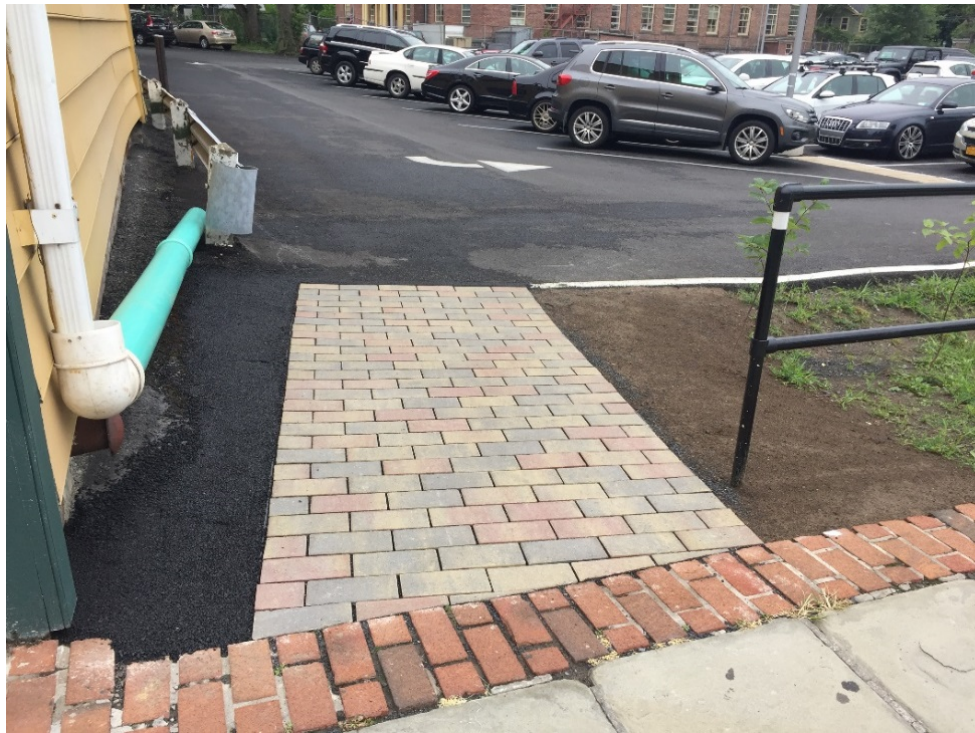
Figure 3.18: Formalized walkway through Bioretention Area South 1 on January 6, 2017 with gravel (top) and on July 14, 2017 with pervious pavers (bottom).

Concrete pervious paver blocks were installed in both bioretention areas to improve the walkway during the first week of July 2017. This was done in the South lot during the first week of July 2017 and in the North lot during the second week of July 2017. At this time, the downspout directing runoff into Bioretention Area South 1 from an adjacent building was redirected into the parking lot and into the drainage area of Dry Well South 3. See Figures 3.17 and 3.18 for the progression of the walkways through Bioretention Area South 1 from informal to formal.

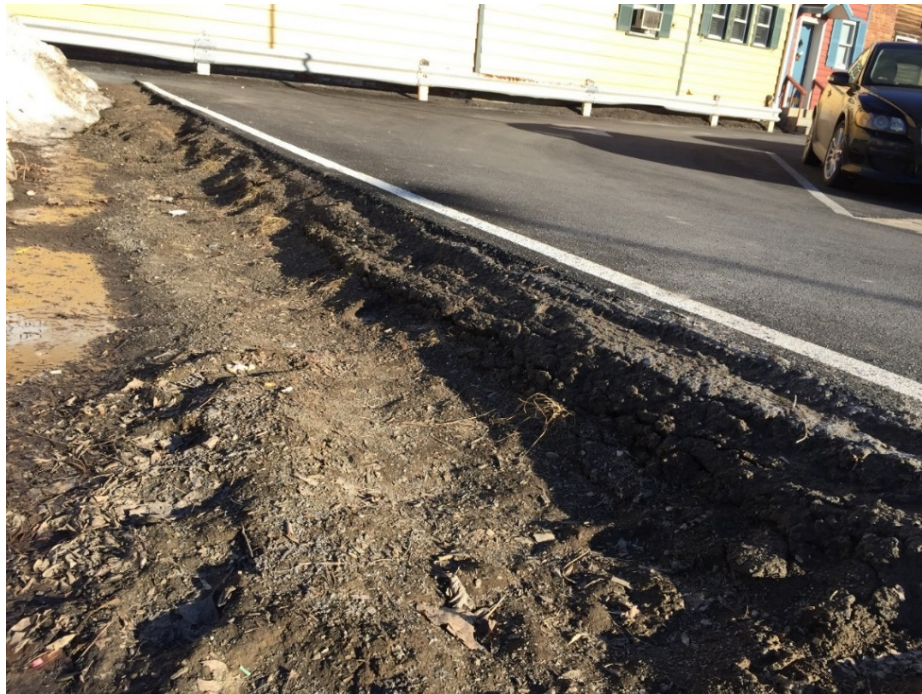
Stormwater entering the practices appeared to contribute to erosion. The sides of Bioretention Area South 2 and Rain Garden South were steep and initially appeared to be eroding, with small rills forming (Figure 3.26). This may have mobilized sediment and moved it to the bottom of the practice, especially as the practices lacked mulch or dense vegetation to help stabilize the slopes. The side of Bioretention Area South 1 in particular was very steep, but later appeared to have stabilized at a gentler slope (Figure 3.27). There may have been some subsidence in the practices, as Rain Garden South in particular appeared to have grown deeper. This may have been from the soil settling, or the weight of the snow that was plowed into the practices.

Figure 3.27: Steep side slopes in Bioretention Area South 1 (February 22, 2017).

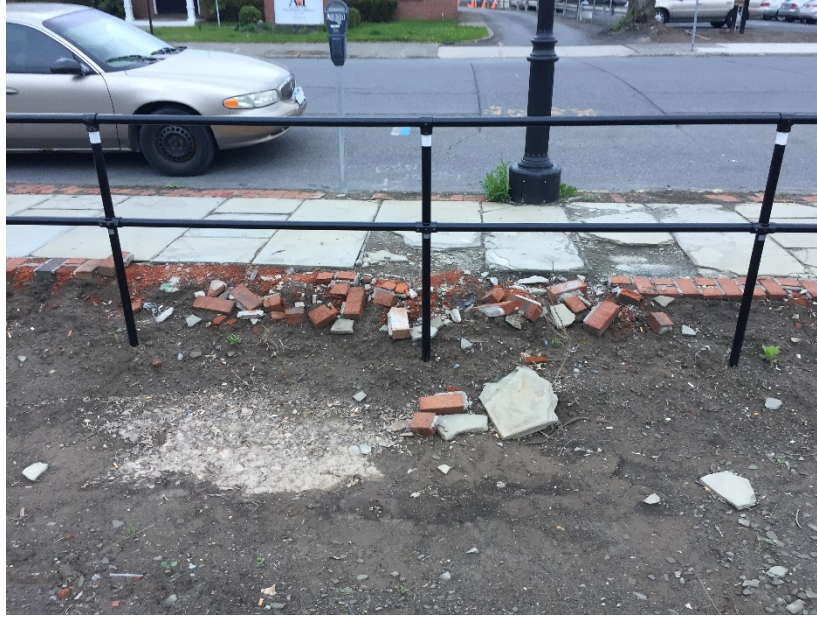
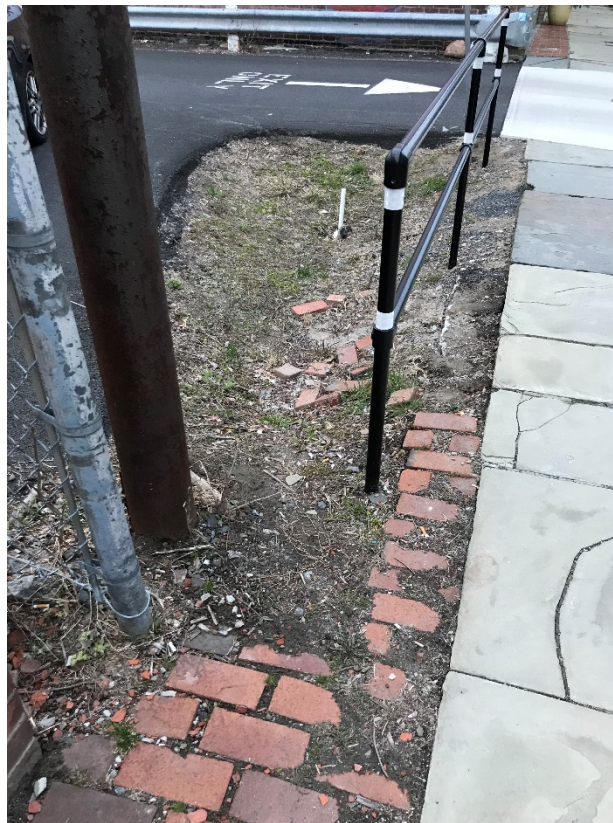
Erosion along the edges of the vegetated practices may have contributed to damage on the hardscape surfaces around them. Bricks that lined the sidewalk adjacent to both Bioretention Area South 2 and Rain Garden South noticeably fell into the practices, and the sidewalks were not repaired (Figure 3.28). The asphalt near Rain Garden South cracked slightly near the practice, which could lead to structural damage over time; the asphalt along Rain Garden North was also deteriorating (Figure 3.29).

Figure 3.28: Bricks from the sidewalks falling into Bioretention Area South 2 (top, April 27, 2017) and Rain Garden South (bottom, April 9, 2018).

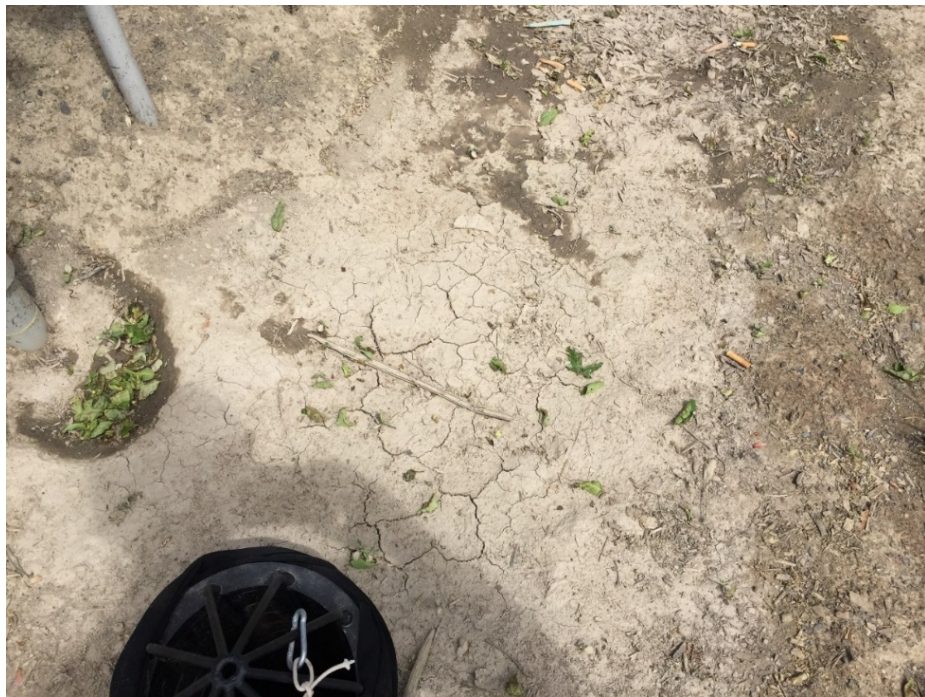
The bottom surface of infiltration practices should be flat to promote infiltration evenly across the surface (NYS DEC 2015). The bottoms of the bioretention practices were not flat, and ponding was deeper in certain areas (Figure 3.31). Although these green infrastructure practices appeared to infiltrate all of the runoff that was directed towards them, they were not using their full surface area for infiltration. This could also be concentrating fine sediment in certain parts of the bioretention area, which could impact performance over time. Bioretention Areas South 1 and South 2 had a layer of clay-y sediment on the surface, which was especially pronounced in dry weather (Figure 3.32).

Figure 3.32: Surface of Bioretention South, with a layer of fine clay-y sediment forming (May 20, 2017).

Within the practices, it may be helpful to re-grade the bottom surface of the bioretention areas so the bottoms of practices are flatter. This would promote more even infiltration across the practice. If the crusty, hard-pan-like layer within the bioretention areas persists, it should be removed, as it could slow infiltration (NYS DEC 2017). No animal burrows or unauthorized plantings were observed, and there did not appear to be sediment accumulating in the underdrains of the bioretention areas (NYS DEC 2017).

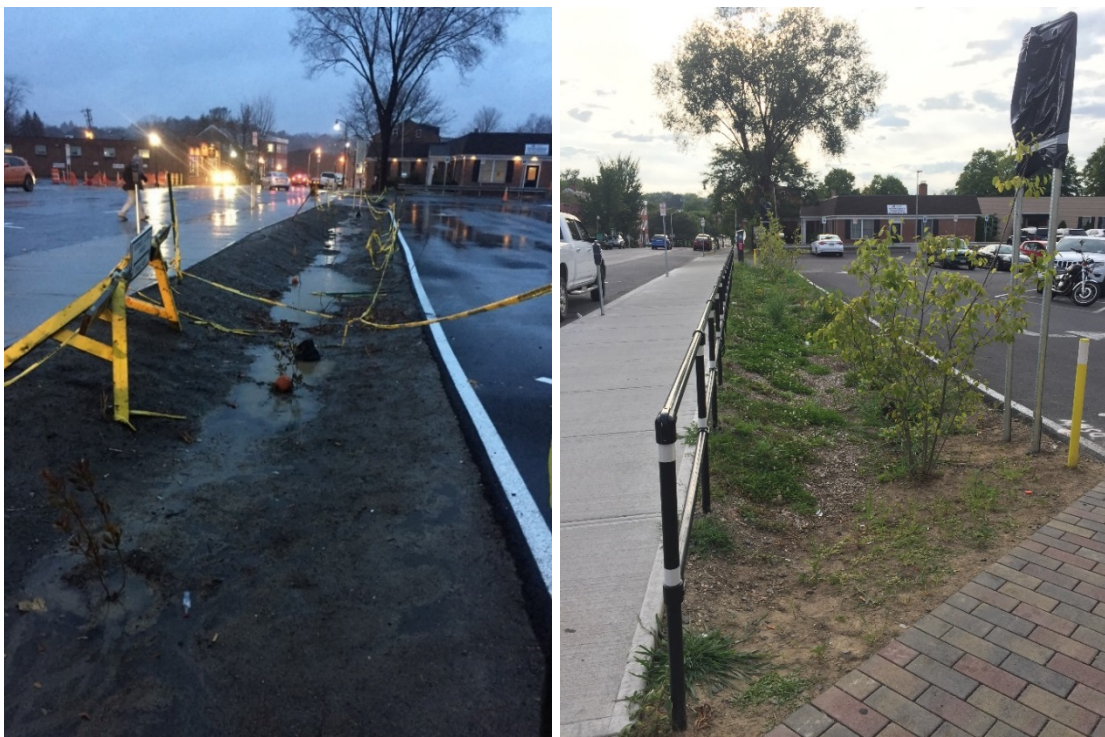
All of the vegetated practices were designed to be depressed and offer physical storage for water to pond (Barton & Loguidice 2015a). However, most of the storage in Bioretention North was filled in with mulch. Over time the surface of the practice was slightly downslope from the sidewalk, but essentially level with the parking lot (Figure 3.33).

Figure 3.33: Ponding in Bioretention North before mulch (left, November 30, 2016). Over time, the practice became mostly flat, without a real depression for storage (right, August 28, 2017).

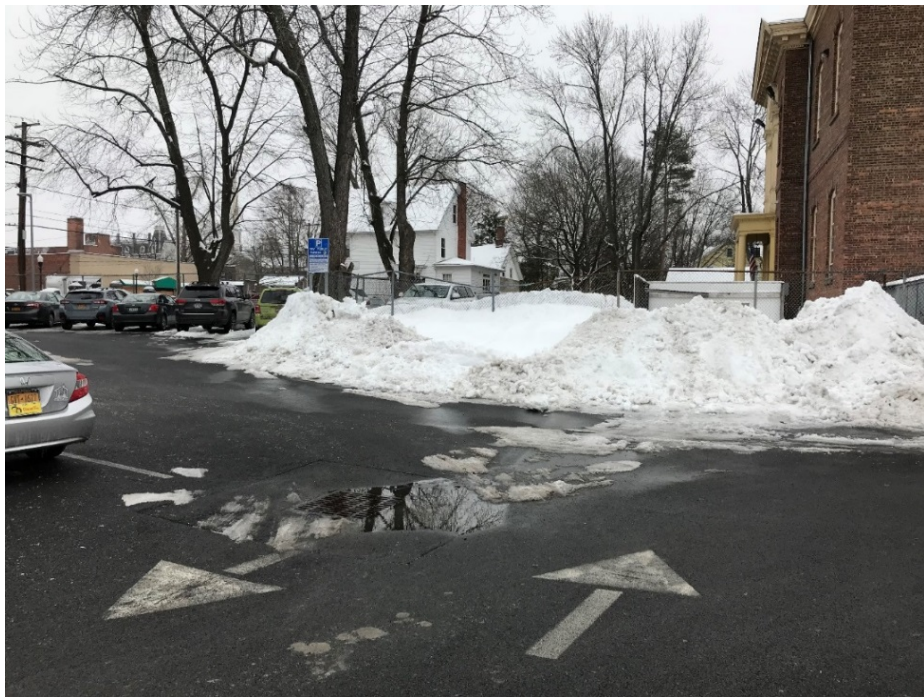
Snow was plowed toward the edges of the lots, and the bioretention areas and rain gardens provided a convenient storage location (Figure 3.37). Most of the snow from the South lot was pushed within the drainage area of Dry Well South 2, which treated a substantial amount of snowmelt (Figure 3.38). The woody vegetation in the bioretention areas was damaged from snow plowing, as previously discussed. Using the green infrastructure practices for snow storage reduced the area available to store runoff, particularly during rain-on-snow events (Figure 3.39).

Figure 3.38: Snowmelt into Dry Well South 2 (February 9, 2018).
